Nonindustrial Timber Management Plan
No: 1-07NTMP-020
Amd: 1-07NTMP-020-DEV6
SWANTON PACIFIC RANCH NTMP

AMENDMENT NO 6 (Major)
TO NTMP

SWANTON PACIFIC RANCH
NTMP #1-07NTMP-020 SCR
MAJOR AMENDMENT:
RECONSTRUCTED ROAD

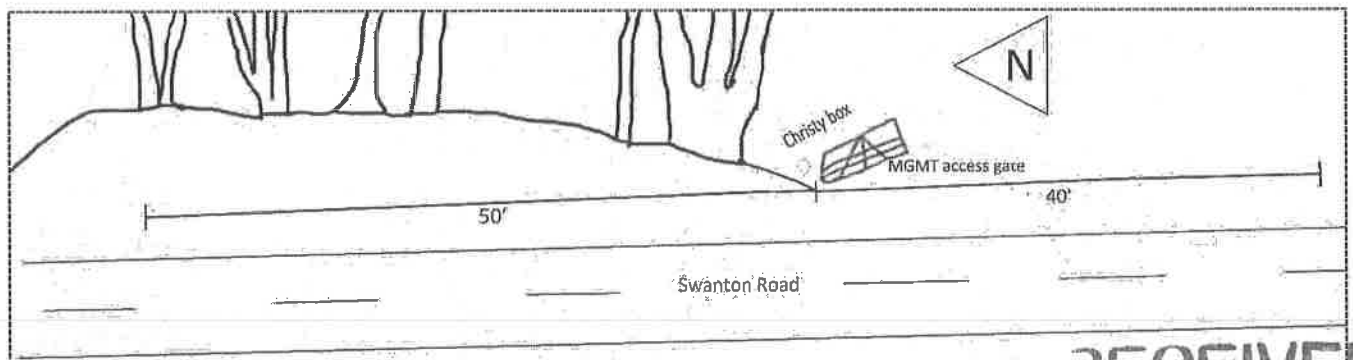
Figure 1. Mitigation Point E (MPE) Sketch of Existing Condition

The location of this mitigation point is at the existing entrance on Swanton Road that accesses Landing L8. The mitigation addresses visibility onto Swanton Road. See Figures 1 and 2 for existing and desired future condition.

- a. From the encroachment to the north, the resulting slope lay back shall be seeded with barley at an application rate of 15 – 25 lbs/acre and straw mulched to a depth of approximately 3 inches. In addition, straw waddles shall be placed parallel every 3 feet on the excavated slope following seeding, but not before straw mulching.

- b. The road from Landing L8 shall not be drained over the newly excavated slope.
 - c. The road from Landing L8 to Swanton Road shall be paved or rocked with $\frac{3}{4}$ " drain rock to a depth of approximately 2 – 3 inches.

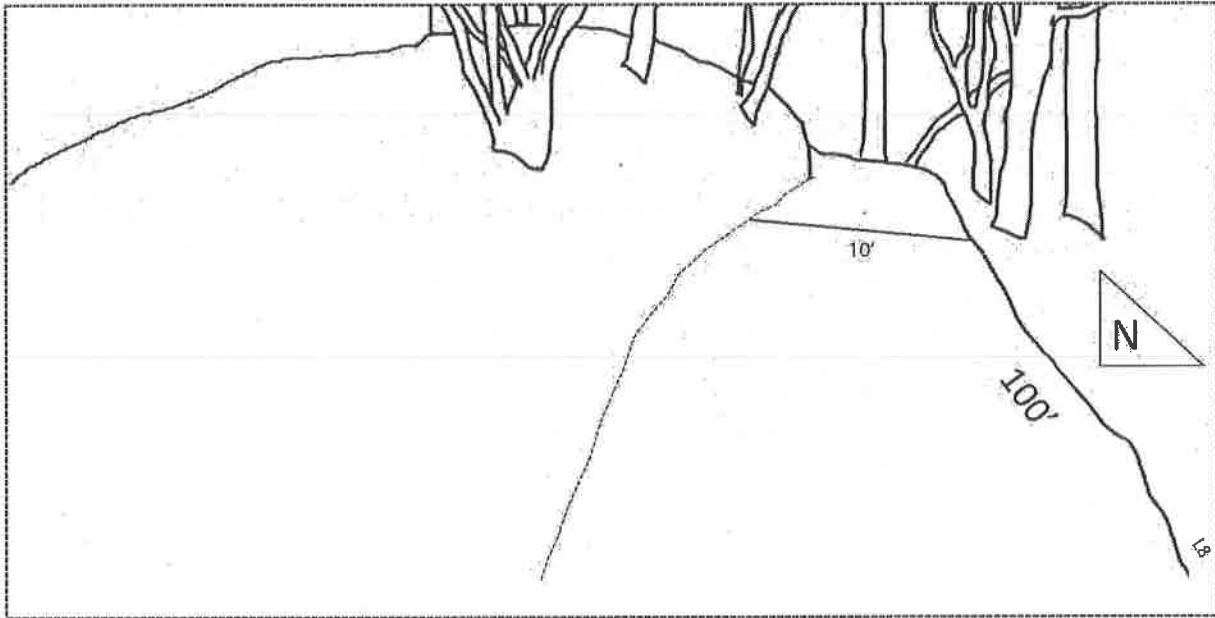
Figure 3. Mitigation Point F (MPF) Sketch of Existing Condition

The location of this mitigation point begins just north of Landing L8 and extends southeast approximately 300 feet. Within this area, there is a 10-foot-wide section of existing road at a slope of approximately 15% for 120 feet. See Figures 3 and 4 for existing and desired future condition.

1. The eastern side of this existing road will be excavated to achieve a 20-foot-wide road. The remaining cutbank shall be laid back at approximately 2:1. The final reconstructed road grade will run at approximately 15% for 300 feet.
2. Harvested trees shall be placed in proximity to Landing L8, Landing L26, or in proximity to the reconstructed road, to be used for firewood if feasible.
3. Excess material from slope lay back, not utilized in balanced cut and fill construction shall be placed on or near Landing L8 or south of Landing L26 on slopes less than approximately 5%. Soil will be spread in uniform layers and compacted in 6 inch lifts, maintaining positive drainage away from the road.
4. Prior to the winter period or following operations Mitigation Point MPF shall be closed-out per the specifications in Soil Stabilization under Item 18, Section II of the NTMP.

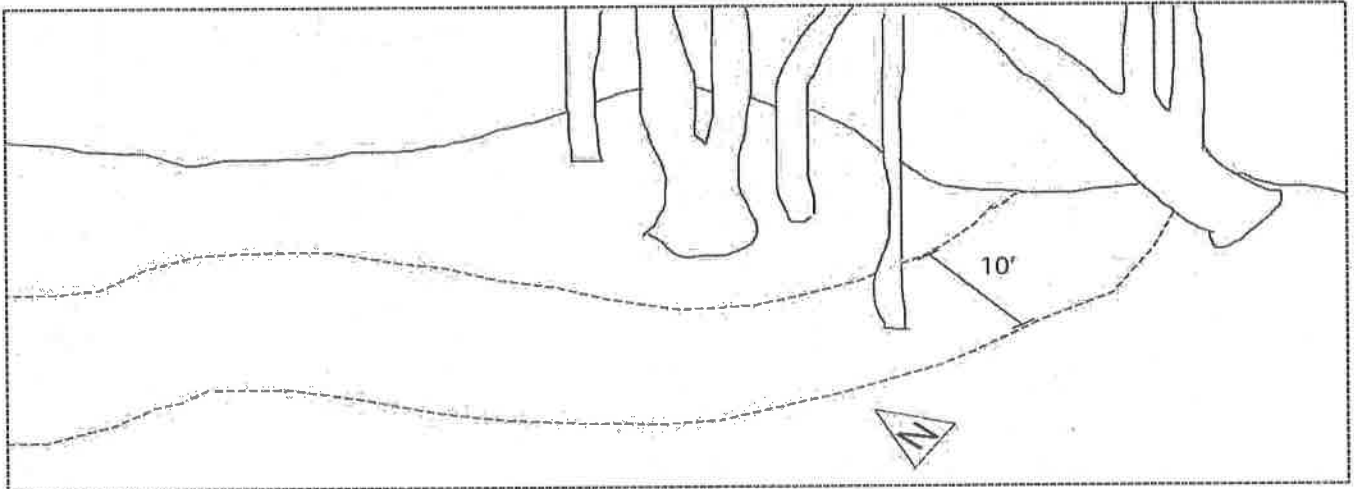
Figure 5. Mitigation Point G (MPG) Sketch of Existing Condition

The location of this mitigation is in proximity to the point where the proposed reconstructed road meets Old School House Gulch Road. To transition the reconstructed road to meet OSHGR, fill will be placed to match the existing grade. See Figures 5 and 6 for existing and desired future condition.

2. The area adjacent the existing road will be sub-excavated approximately 2-3 feet to create a keyway for fill in order to transition the realignment onto OSHGR.
3. Soil will be compacted in approximately 6 inch lifts from the toe to the finished grade.
4. Prior to the winter period or following operations, the reconstructed road shall be closed-out per the specifications under Item 18, Soil Stabilization, in Section II of the NTMP.

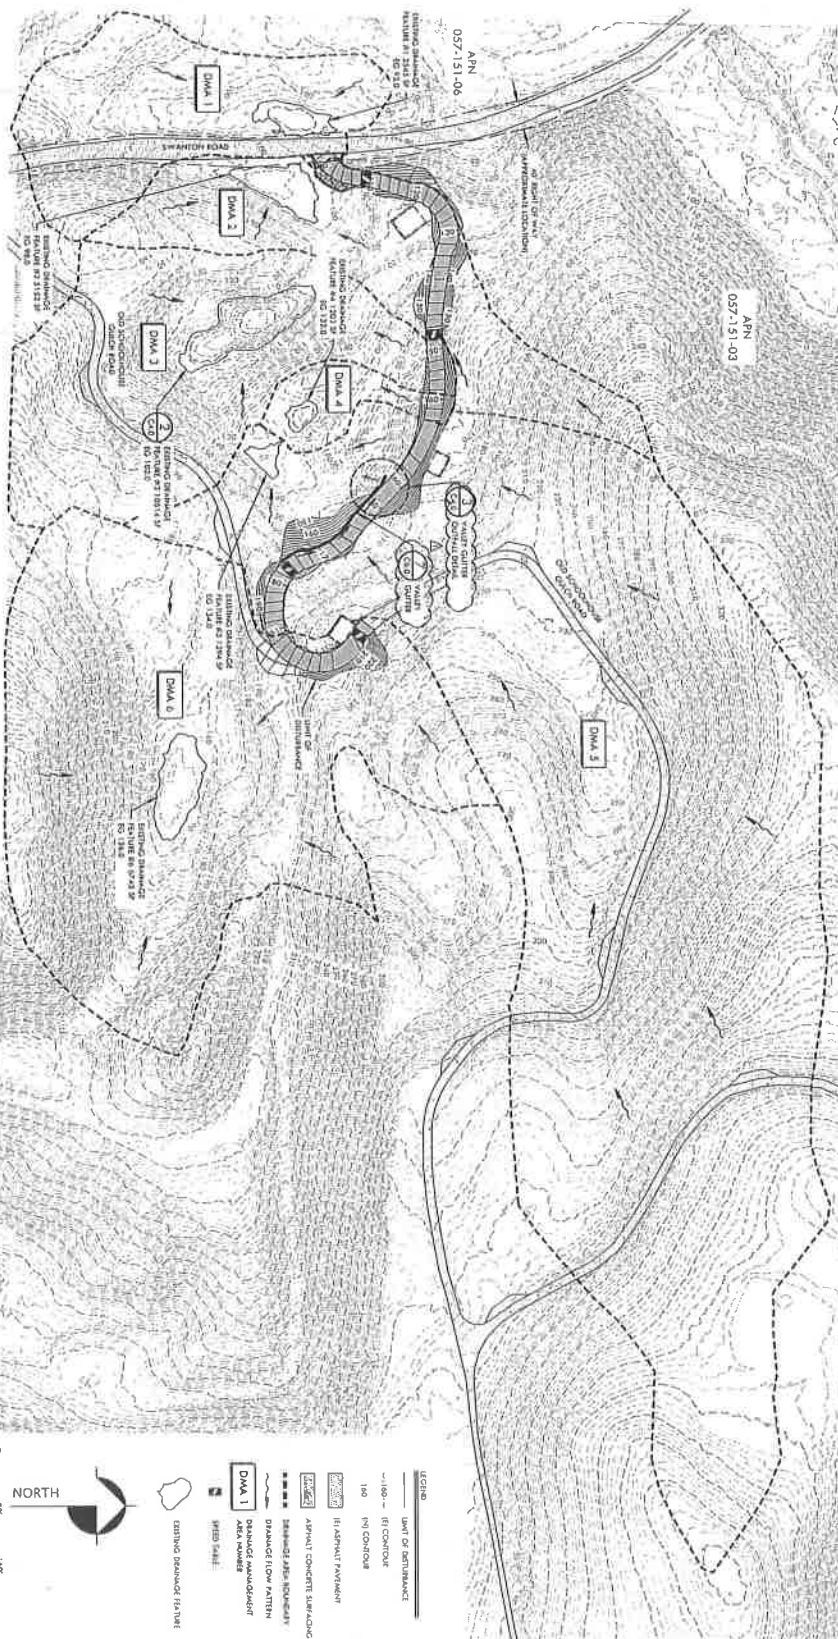
1 DRAINAGE PLAN

1. GRAINAGE CALCULATIONS ARE BASED ON THE DESIGN CRITERIA PROVIDED IN SECTION 4.0 "ON-SET DETENTION OF STORMWATER RUNOFF" OF THE COUNTY OF SANTA CLAUZ DESIGN CRITERIA PART 3, STORMWATER MANAGEMENT.
2. "FATIGUES OVERFLOW TO DRAINAGE FEATURE 3."

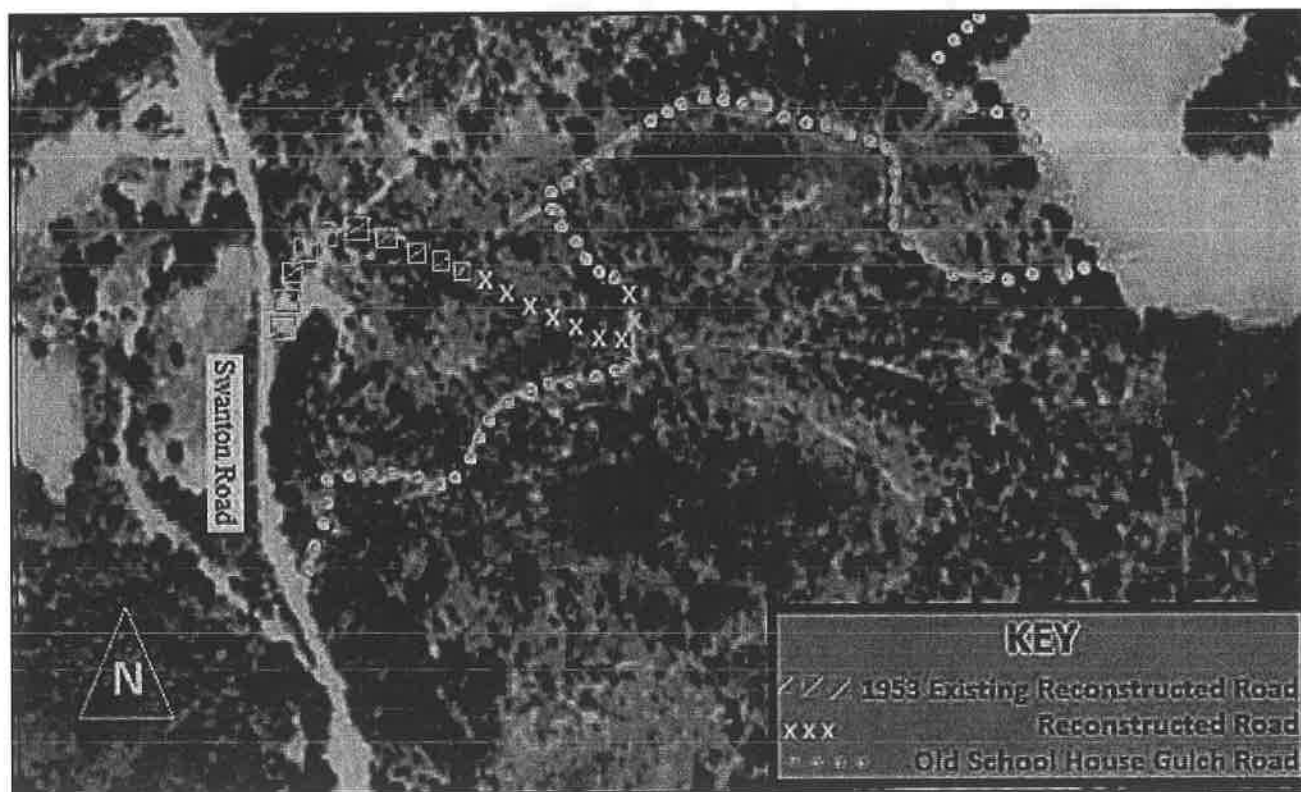
Figure 2. Aerial Photo from 1953 showing the current alignment of Old School House Gulch Road, as well as portion of the existing proposed alignment.

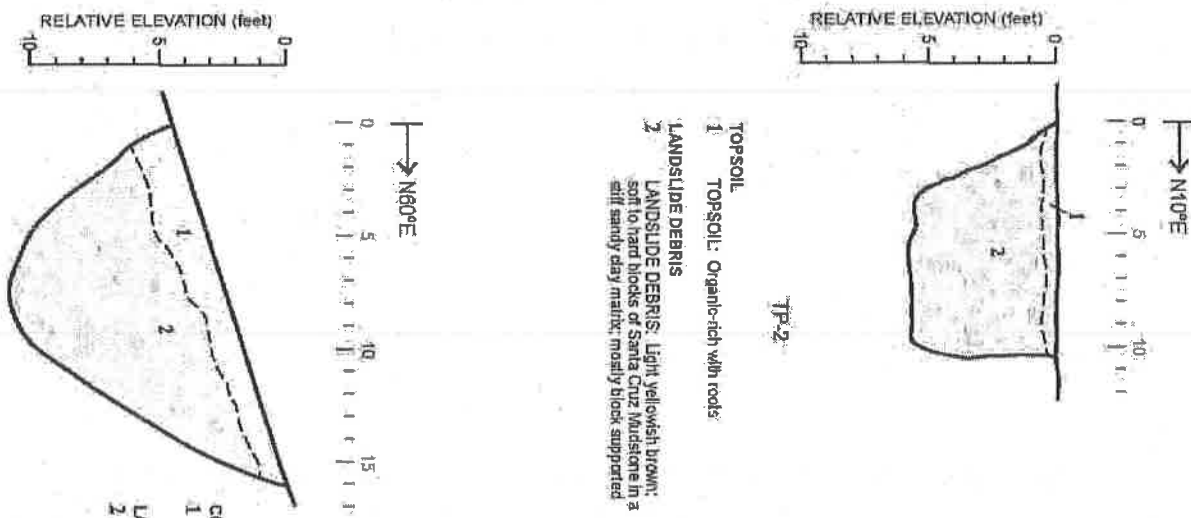
Geo-Logic ASSOCIATES		DATE MAY 2017		LOGS of TEST PITS TP-2, TP-3, TP-4, and TP-5 IMPROVED ACCESS ROAD REALIGNMENT SWANTON PACIFIC RANCH DAVENPORT, CALIFORNIA		FIGURE 2	
				PROJECT 2014.01.13

place bedrock) was observed on several topographic highs along or adjacent to the proposed road alignment. Test pit logs are included on Figure 2.

Test pits TP-1 and TP-2 were excavated at approximately Sta. 2+10. We encountered refusal conditions on relatively competent hard blocks of Tsc at the ground surface in TP-1, located on the south side of the alignment. We photographed this shallow test pit (approximately 6" deep) but did not produce a drafted field log. Test pit TP-2, on the north side of the alignment at approximately the same station, encountered landslide debris consisting of soft to hard blocks of yellowish brown Santa Cruz Mudstone entrained in soft sandy clay matrix. Test pits TP-1 and TP-2 illustrate the wide range of subsurface conditions possible within a small area, as is typical of landslide terrain.

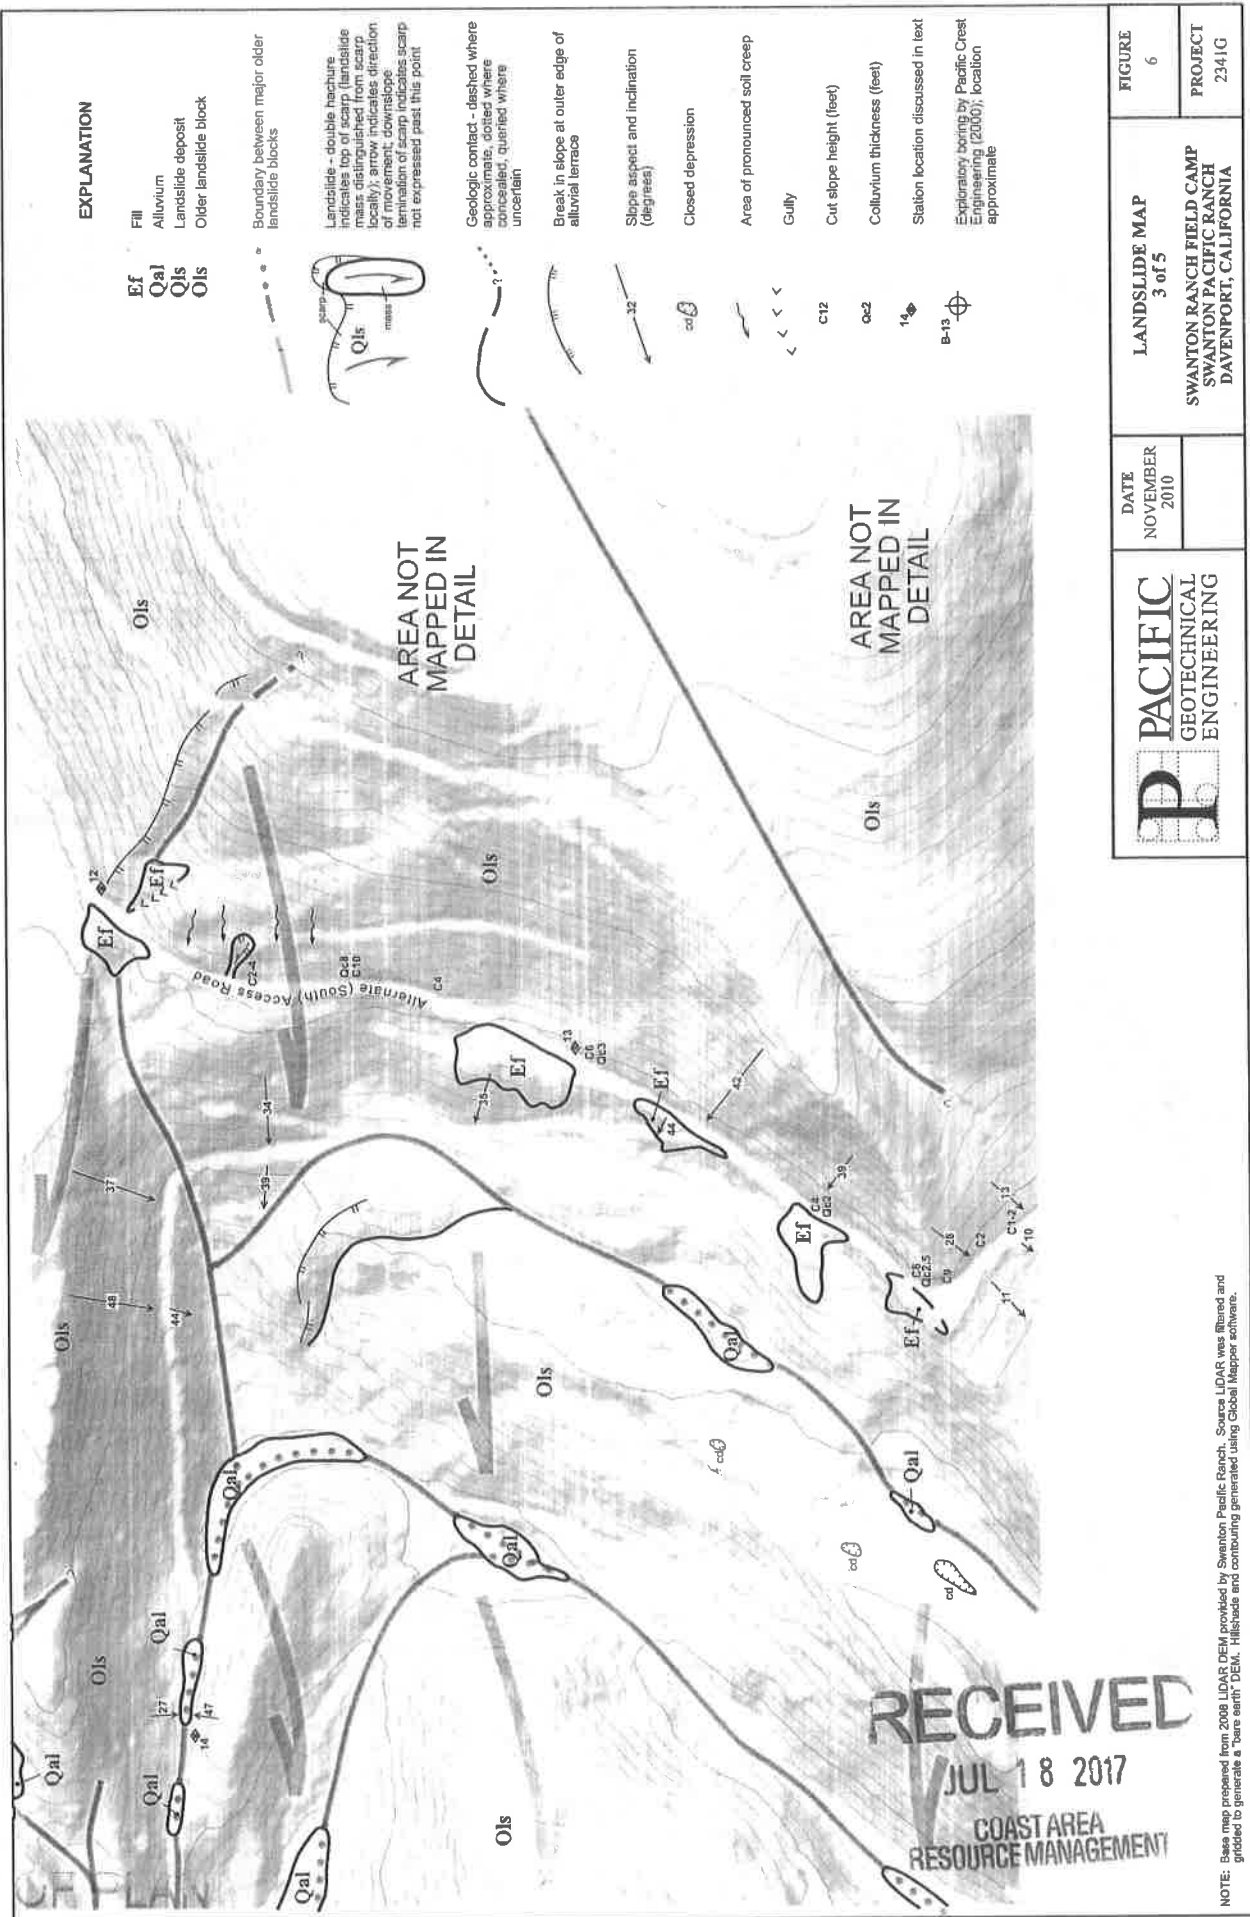
FIGURE 6	LANDSLIDE MAP 3 of 5	DATE NOVEMBER 2010
PROJECT 2341G	SWANTON RANCH FIELD CAMP SWANTON PACIFIC RANCH DAVENPORT, CALIFORNIA

NOTE: Base map prepared from 2008 LIDAR DEM provided by Swanton Pacific Ranch. Source LIDAR was filtered and gridded to generate a "bare earth" DEM. Hillshade and contouring generated using Global Mapper software.

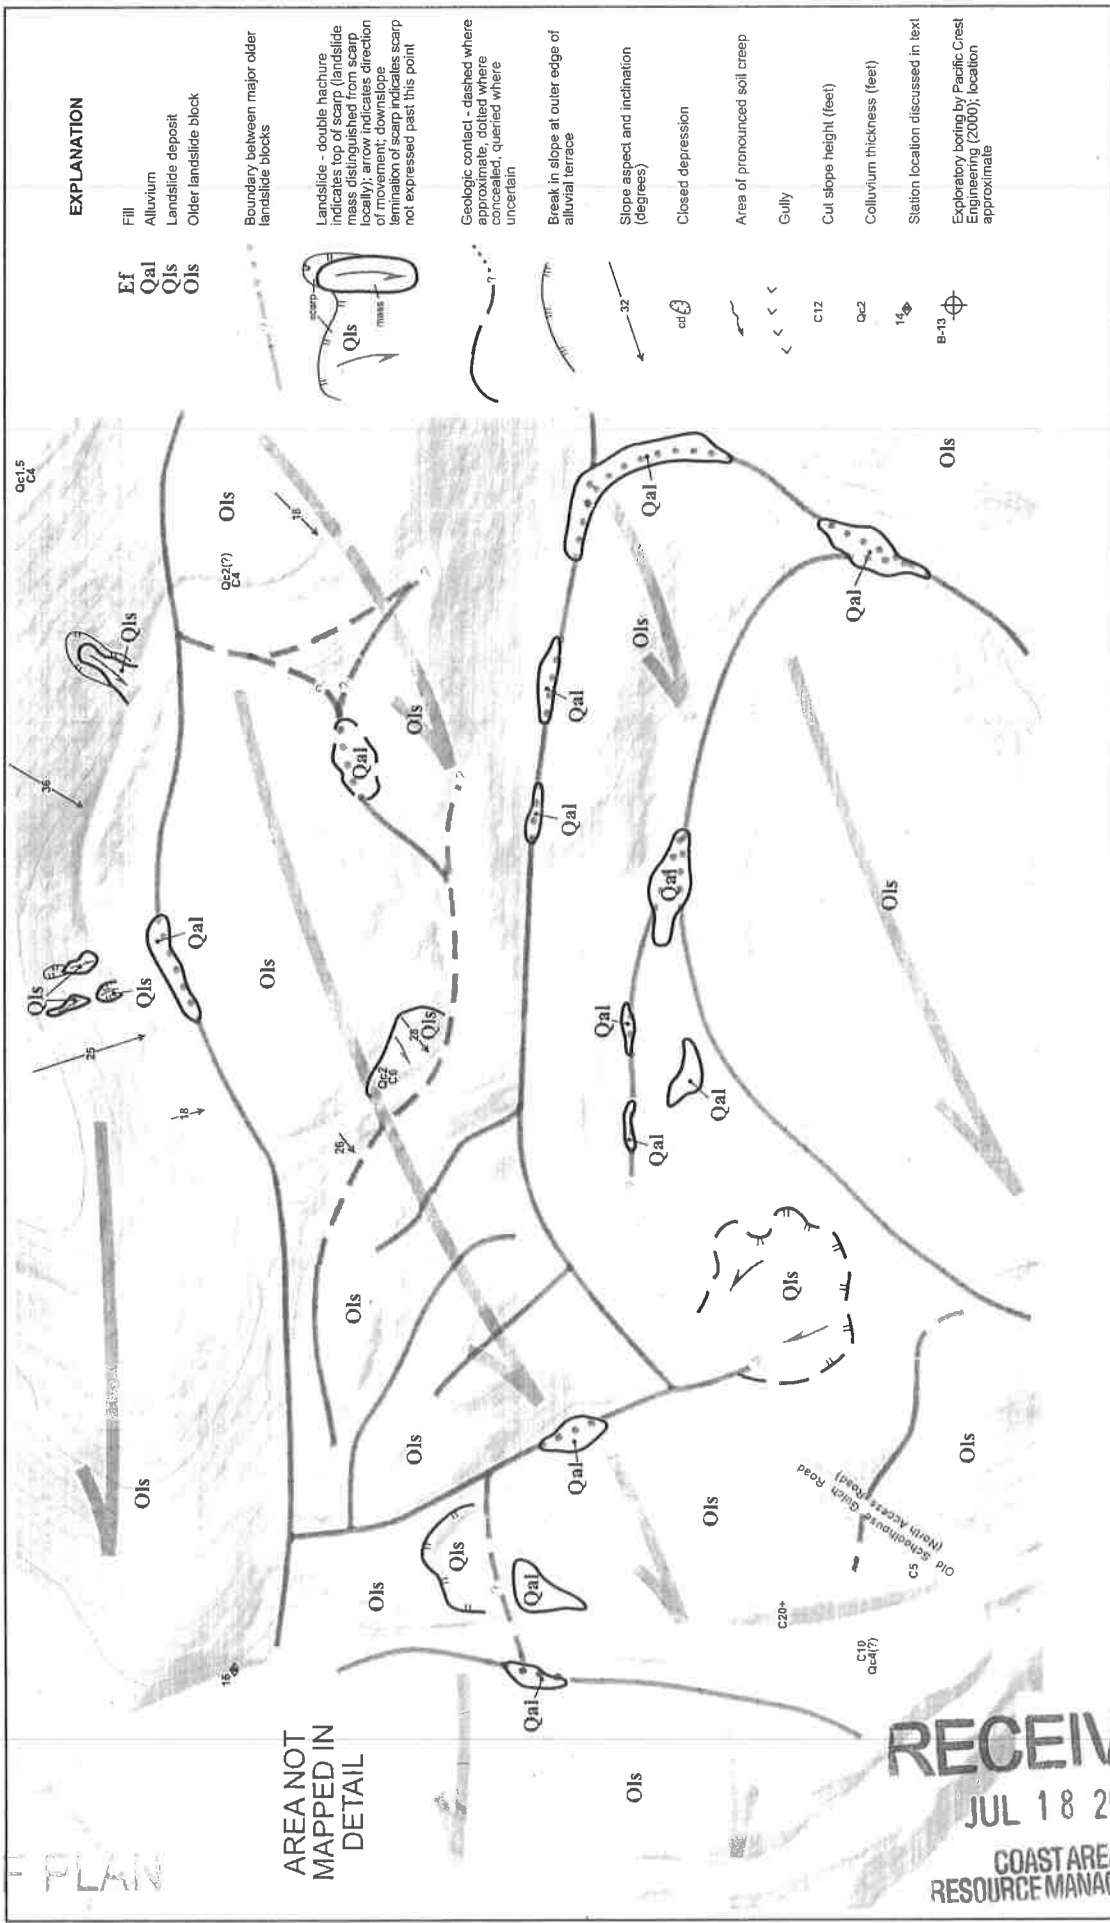
DATE NOVEMBER 2010	LANDSLIDE MAP 4 of 5 SWANTON RANCH FIELD CAMP SWANTON PACIFIC RANCH DAVENPORT, CALIFORNIA	FIGURE 7 PROJECT 2341G
--	------------------------------	--	---

NOTE: Base map prepared from 2008 LIDAR DEM provided by Swanton Pacific Ranch. Source LIDAR was filtered and gridded to generate a "bare earth" DEM. Hillshade and contouring generated using Global Mapper software.

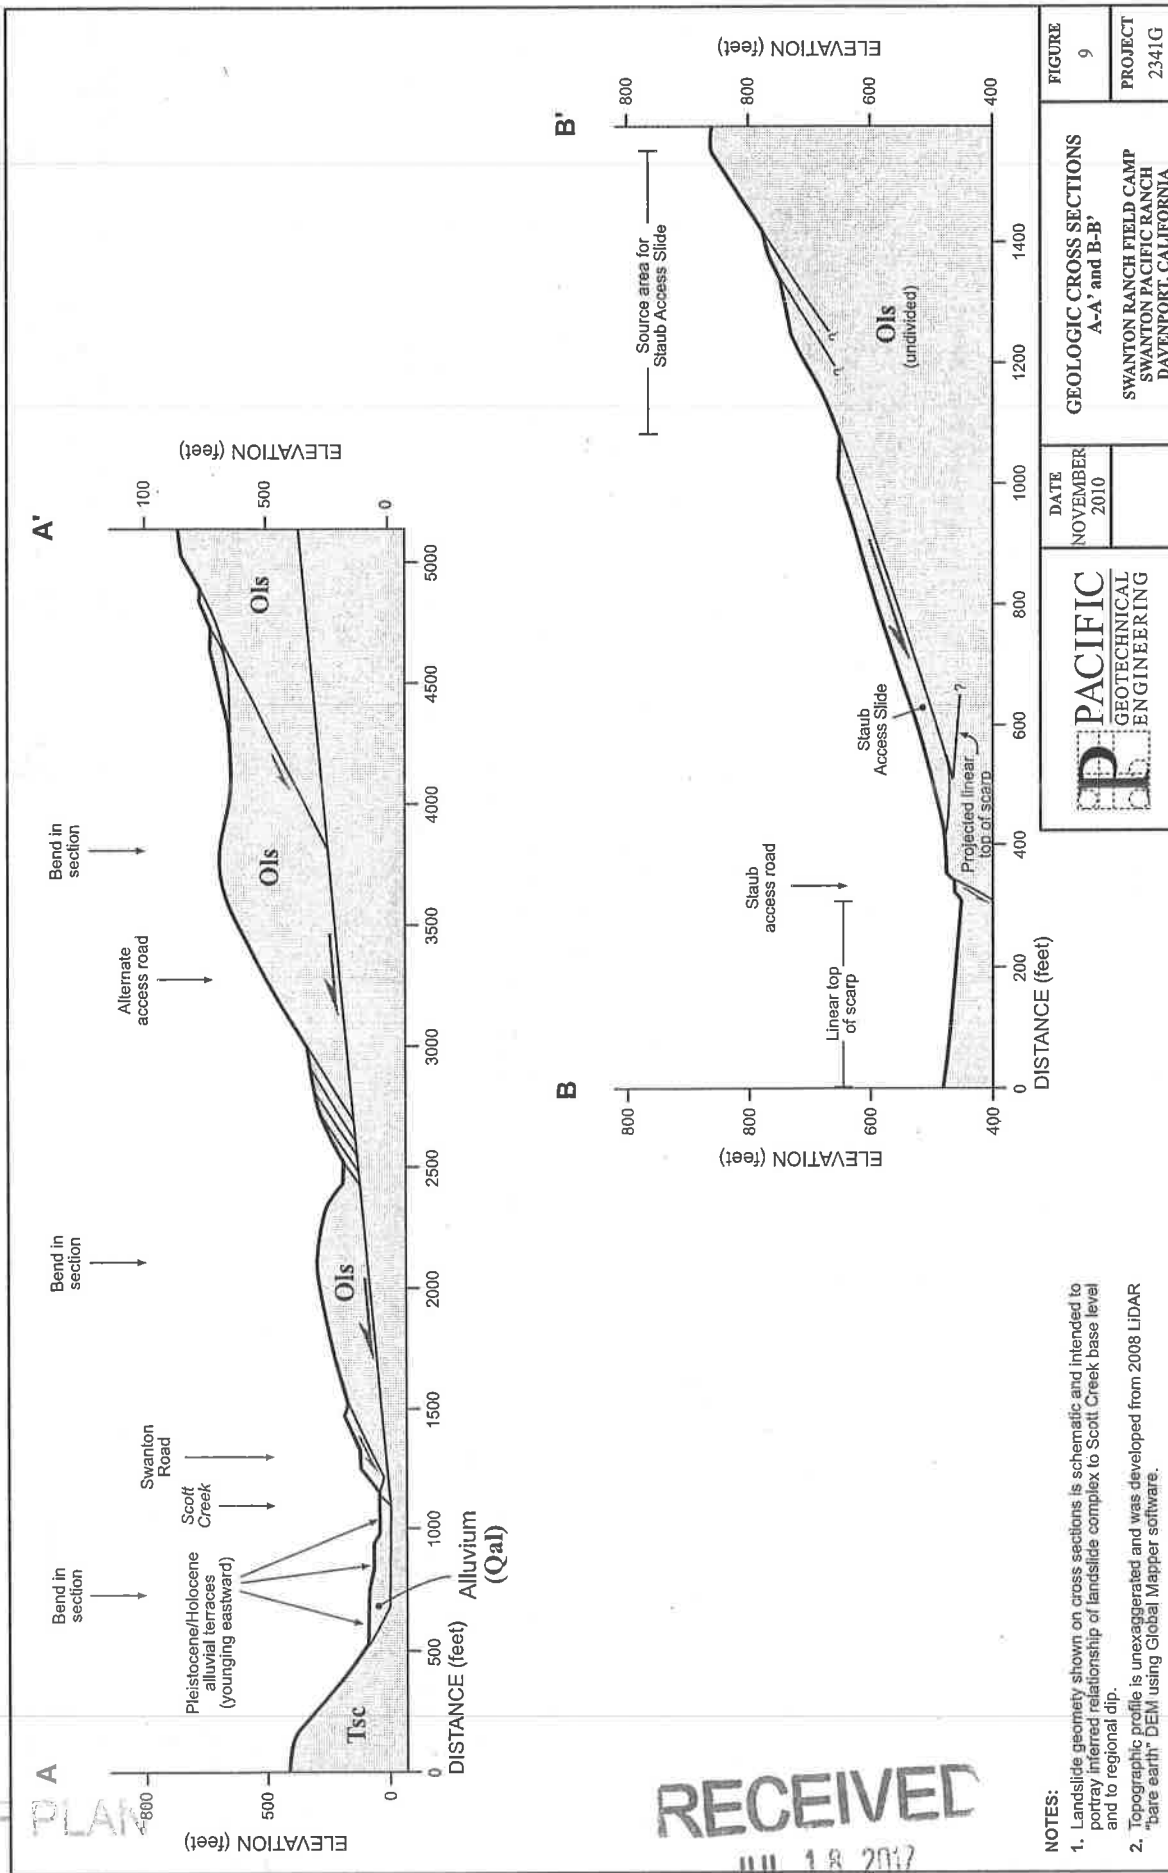
1. Landslide geometry shown on cross sections is schematic and intended to portray inferred relationship of landslide complex to Scott Creek base level and to regional dip.
2. Topographic profile is unexaggerated and was developed from 2008 LIDAR "bare earth" DEM using Global Mapper software.
